Channel Stability Problems, Pajaro River, Watsonville and Pajaro, California

**U.S. Army Engineer Committee on Channel
Stabilization Report of the 63rd Meeting**

Ronald R. Copeland and Dinah N. McComas, editors

August 2000

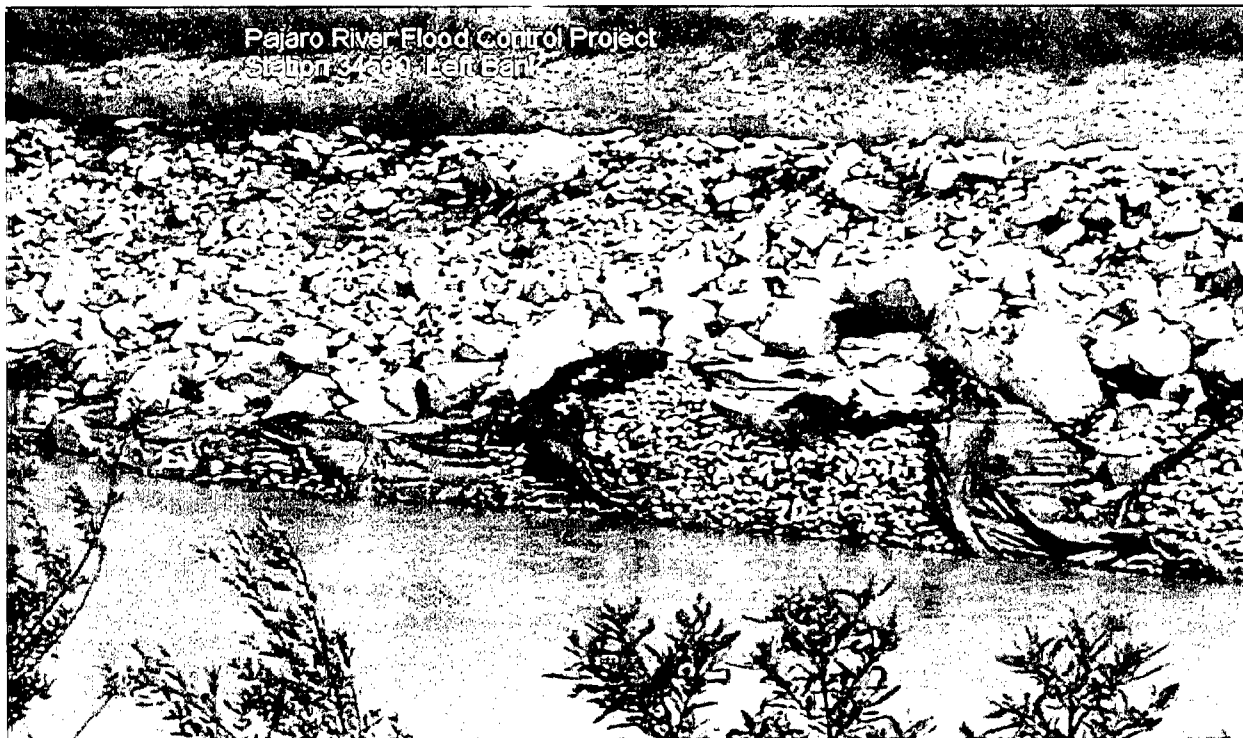
- c. The locations where the banks have been stabilized are very steep. Also, the stone, although apparently well graded, is inconsistent in size. The erosion control mats have been installed incorrectly and/or have been applied to situations for which they were not intended (see Figure 6).

Figure 6. Incorrect installation of erosion control mats

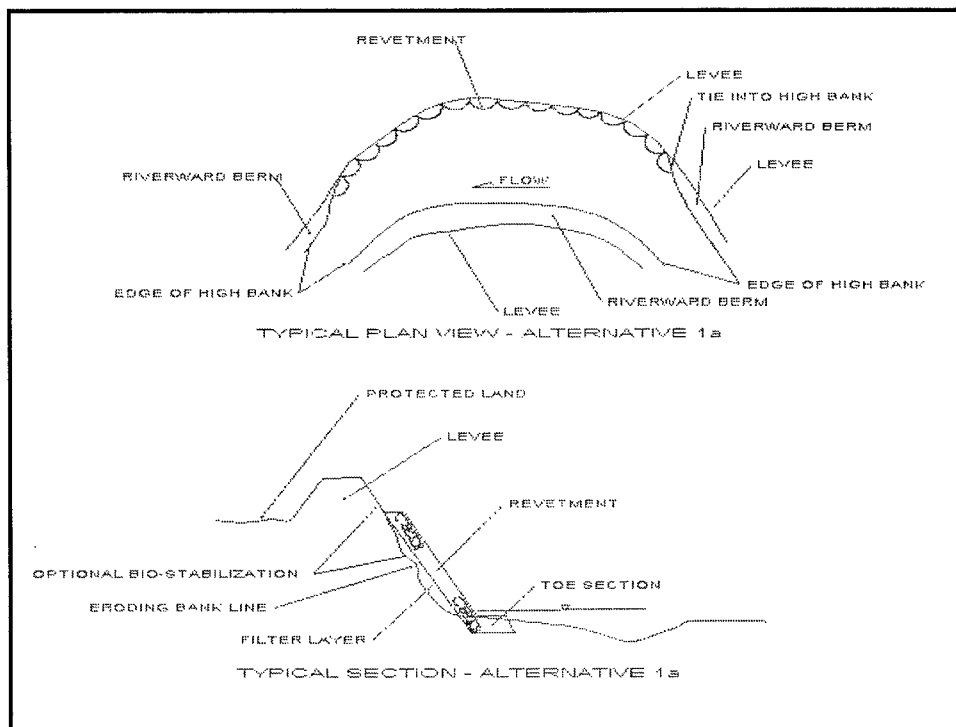
Figure 7. Alternative 1a

The Committee looked at two different scenarios for bank stabilization: first, where the bank has eroded up to the toe of the levee (within 10 ft); and second, where the bank has eroded to within 30 ft of the levee toe. For the first case the Committee developed three alternatives for stabilizing the banks (Figures 7 and 8). Alternatives for the second case are shown in Figure 9.
